Worldwide repairs carried out with PolymerMetal®

REP-# 093

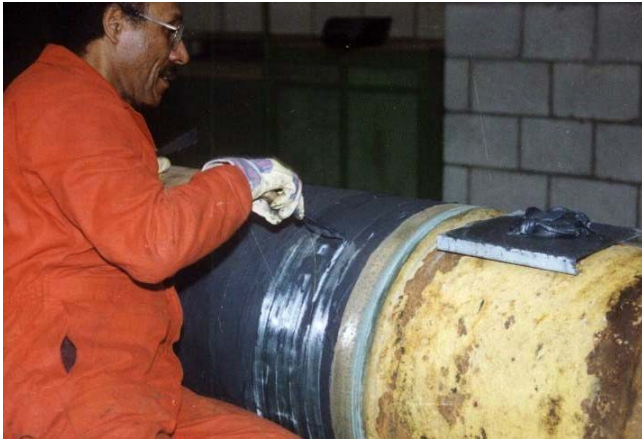
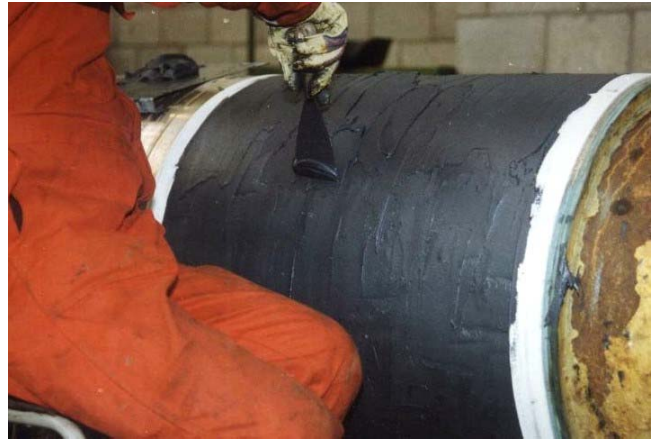
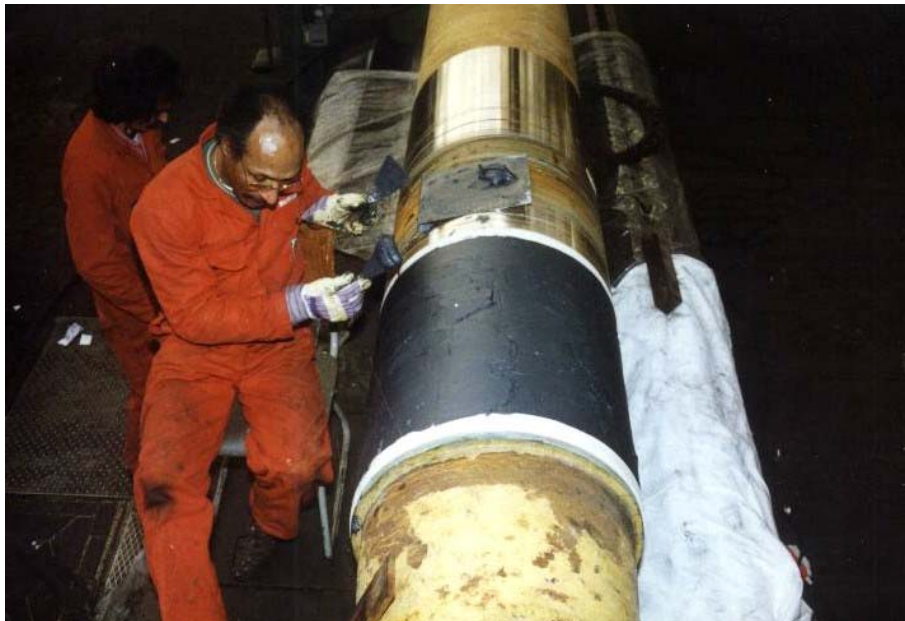
Repair of a ship propeller shaft made of bronze in the zone of the stuffing box packing with Ceramium pasty and Hardener CE. The original shaft diameter of 630 mm was machined down to 615 mm over a length of 60 cm. After the application of Ceramium the diameter was 632 mm. Finally the applied Ceramium was turned down to the requested diameter. For the complete repair 39 units of Ceramium / Hardener CE were used for applying 4 layers. Additionally 3 layers of glass fibre fabric tape were processed.
